Model: Martini-C1		Date: 13-Sep-02	No.: RB064001
Subject: ROM History (Martini-C1 LCDC/Language)		Prepared by: K. Miura	
From: Technical Services sec. Service Planning Dept.			
Classification:	<input type="checkbox"/> Troubleshooting <input type="checkbox"/> Part information <input type="checkbox"/> Action required <input type="checkbox"/> Mechanical <input type="checkbox"/> Electrical <input type="checkbox"/> Service manual revision <input type="checkbox"/> Paper path <input type="checkbox"/> Transmit/receive <input checked="" type="checkbox"/> Retrofit information <input type="checkbox"/> Other (      )

Firmware history for the Martini-C1 LCDC/Language.

Model: Martini-C1		Date: 1-Nov-02	No.: RB064007
Subject: Transfer Belt Damage (NA Field Only)		Prepared by: K. Miura	
From: Technical Services sec. Service Planning Dept.			
Classification:	<input checked="" type="checkbox"/> Troubleshooting	<input type="checkbox"/> Part information	<input type="checkbox"/> Action required
	<input type="checkbox"/> Mechanical	<input type="checkbox"/> Electrical	<input type="checkbox"/> Service manual revision
	<input type="checkbox"/> Paper path	<input type="checkbox"/> Transmit/receive	<input t

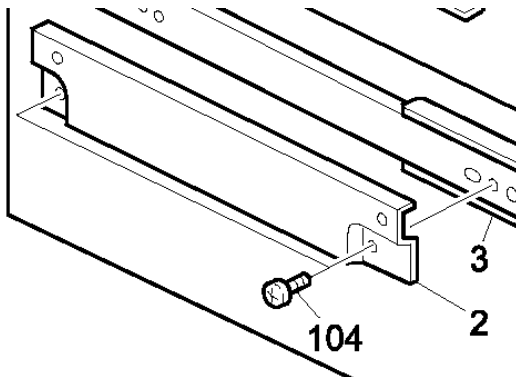
The screw shown below (Frame section 20, P/N #04533006B, pg. 45 #104) comes loose and detaches from the slide rail bracket.

Vibration during transport.

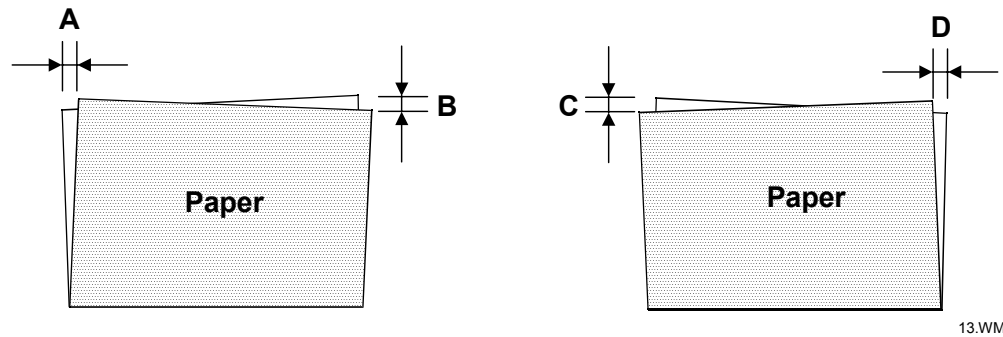
11. Check the copies for booklet folding skew, i.e. all distances shown below (A, B, C, D) should be 2mm or less.

12. If A/B or C/D are over 2 mm, adjust the folding position using SP6120 until the two edges intersect in the middle (point X).

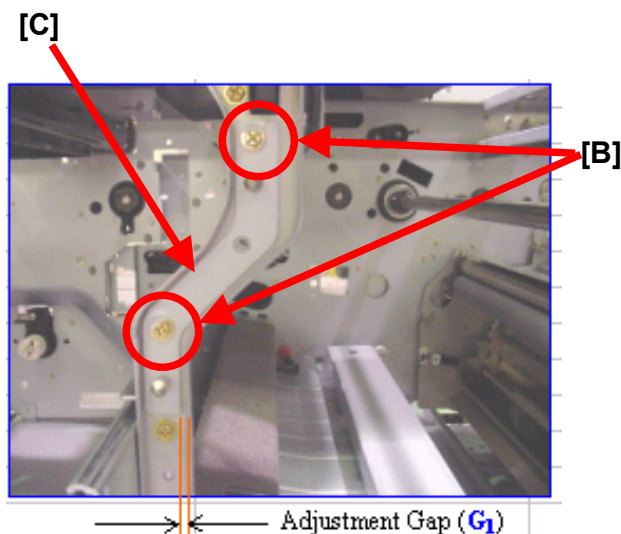
Due to a damaged special tool used on the production line, a 2.3mm gap developed between the positioning plate securing the transfer belt unit and the right edge of the machine frame (gap G<sub>1</sub> on next page, which should normally be about 1.5mm).

2. Remove the PCU Inner Cover (P/N B0651313), then remove the Transfer Unit Guide Plate [A].
3. Loosen the 2 paint-locked screws [B].
4. Insert a 1.5mm feeler gauge into the gap between the positioning plate [C] and the right edge of the machine frame (gap  $G_1$  in photo below), then tighten the two positioning plate screws.

**NOTE:** Adjust the gap in increments of about 0.2mm. Then, repeat Steps 2 thru 6 until the transfer belt does not contact either edge through 100 sheets of duplex copies.

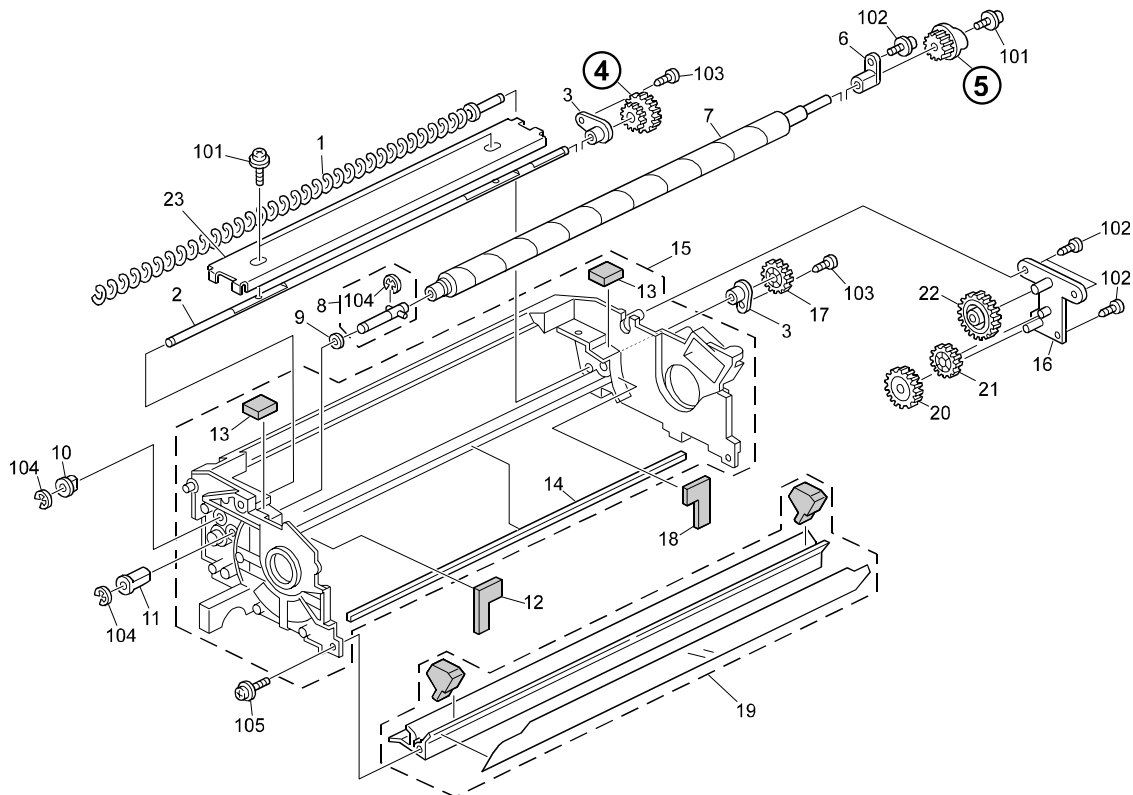
Noise from the PCU brush roller gear (PCU3 section 37, pg. 87, index #4, 5; P/N #B0652425, B0652428). In some cases the brush roller gear may break and black lines may appear, because the brush roller does not rotate.

*The PCU brush wears down or becomes dirty, decreasing the friction between it and the inner wall of the PCU. This friction normally stops the cam, but as it decreases, the cam is rotated too far and contacts the stopper screw repeatedly. The gear can be damaged by this alone, or when the cam overrides the screw and cannot be turned back, applying an excessive load on the gear.*

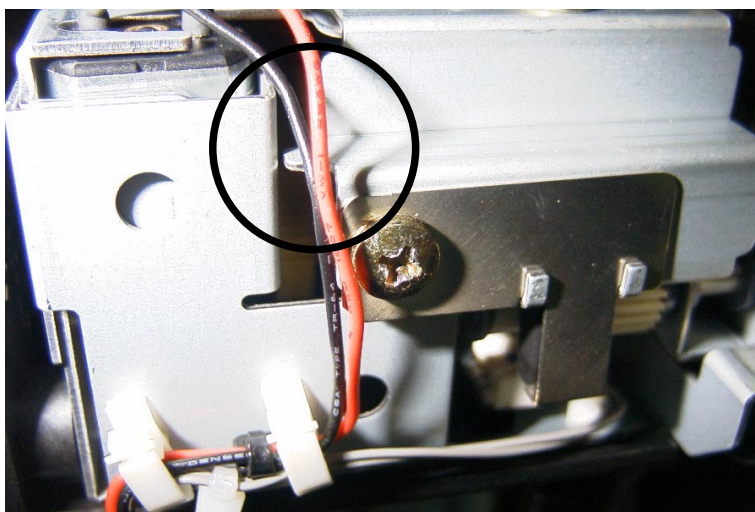
The harness is led as shown below during factory assembly.

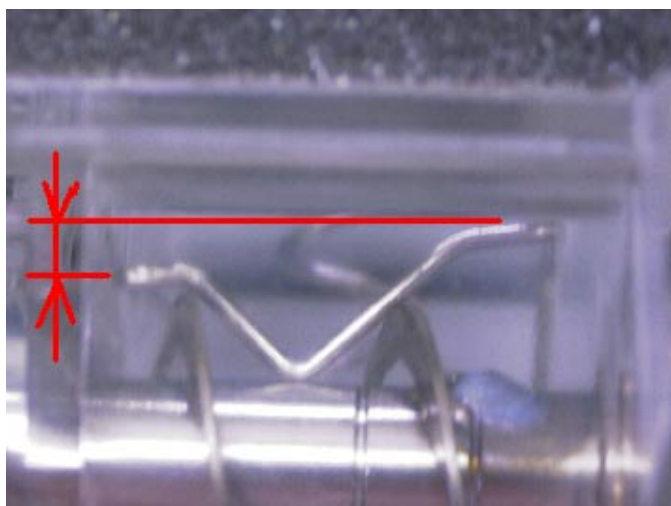
**Note:** This only occurs on certain toner supply cases (see the affected machine S/N below).

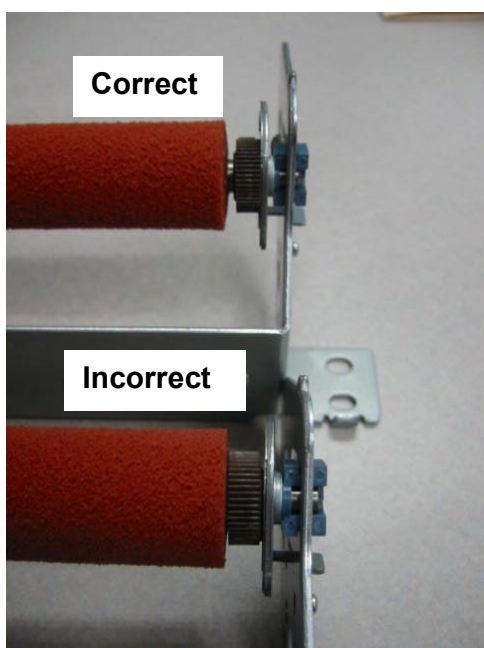
The upper photo shows the **correct** orientation (large gap), while the bottom one shows the incorrect orientation (hardly any gap visible).

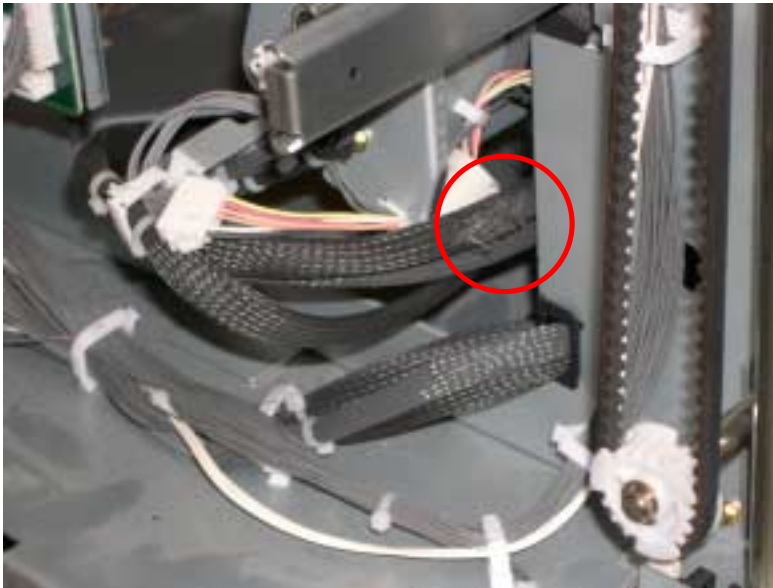
The outside of the stapler harness is damaged in the area shown in the photo. In some cases, a short circuit occurs in the damaged area.
