Model: Martini-C2	Date: 14-Oct-04	No.: RB140001b
-------------------	-----------------	----------------

Subject: Firmware Release History (BCU - Engine)		Prepared by: S. Watanabe	
From: 2nd Tech Support Sec. Service Support Dept.			
Classification:	<input type="checkbox"/> Troubleshooting	<input type="checkbox"/> Part information	<input type="checkbox"/> Action required
	<input type="checkbox"/> Mechanical	<input type="checkbox"/> Electrical	<input type="checkbox"/> Service manual revision
	<input type="checkbox"/> Paper path	<input type="checkbox"/> Transmit/receive	<input type="checkbox"/> Retrofit information
	<input checked="" type="checkbox"/> Other ()

This RTB has been issued to announce the firmware release information for the Engine.

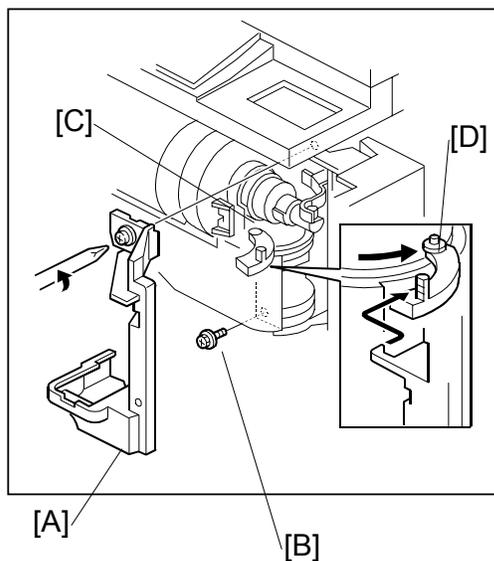
IMPORTANT: Before you begin, **remove the toner bottle** if it is installed.

Note: If the toner bottle is in the machine when you do this procedure, the toner bottle holder can be damaged.

1. Remove the shutter cover [A] of the toner supply unit (⌀ x 1).
2. Remove the lock screw [B] from the toner bottle open/close bracket.
3. Remove the shipping tape [C] if it is still there.
4. Pull the toner bottle holder and swing it to the right.

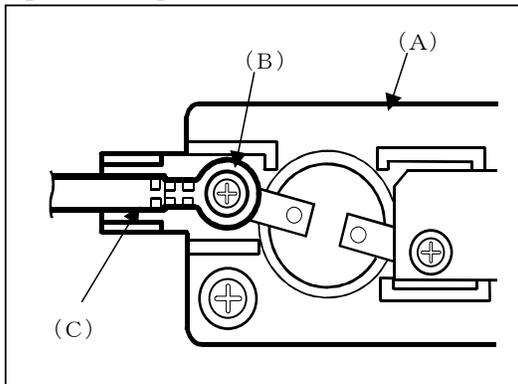
[Correct]

NOTE: If you do not put the harness in between the bracket ribs (see "Incorrect"), a thermostat disconnection or SC542/545 error may occur.

Do the following when you replace the thermostat (P/N#AW110040: Thermostat-192C) on the MT-C2.

- Put the end of the thermostat harness that has the round lead [B] **in between the two bracket ribs [C]**.
- Tighten the screw for the round lead [B] **as tight as you can**. Do not damage the screw or screw hole.

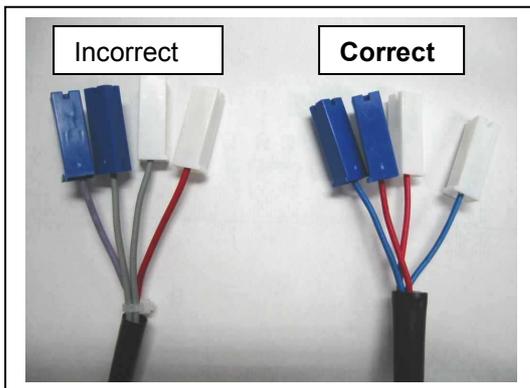
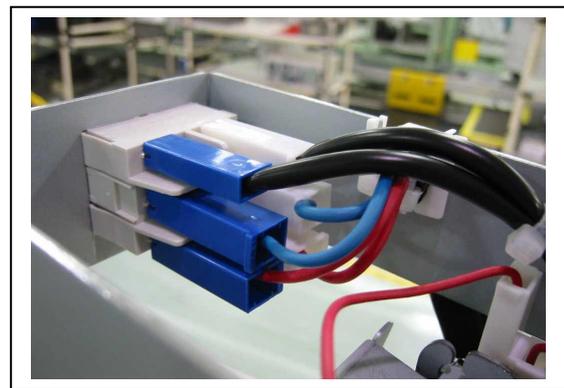
- Harness: P/N B1405615, "Harness: AC Power: Main: NA", index 22, pg.139 on the Parts Catalog
- This only occurs on the machines listed below.

Error by the vendor during the harness assembly process

When you replace the PSU on the machines listed below, attach the connectors according to the color of the **connectors**. Ignore the color of the harness cables.
