Model: Martini-C1		Date: 13-Sep-02	No.: RB064001
Subject: ROM History (Martini-C1 LCDC/Language)		Prepared by: K. Miura	
From: Technical Services sec. Service Planning Dept.			
Classification:	<input type="checkbox"/> Troubleshooting <input type="checkbox"/> Part information <input type="checkbox"/> Action required <input type="checkbox"/> Mechanical <input type="checkbox"/> Electrical <input type="checkbox"/> Service manual revision <input type="checkbox"/> Paper path <input type="checkbox"/> Transmit/receive <input checked="" type="checkbox"/> Retrofit information <input type="checkbox"/> Other (      )

Firmware history for the Martini-C1 LCDC/Language.

Model: Martini-C1		Date: 1-Nov-02	No.: RB064007
Subject: Transfer Belt Damage (NA Field Only)		Prepared by: K. Miura	
From: Technical Services sec. Service Planning Dept.			
Classification:	<input checked="" type="checkbox"/> Troubleshooting	<input type="checkbox"/> Part information	<input type="checkbox"/> Action required
	<input type="checkbox"/> Mechanical	<input type="checkbox"/> Electrical	<input type="checkbox"/> Service manual revision
	<input type="checkbox"/> Paper path	<input type="checkbox"/> Transmit/receive	<input t

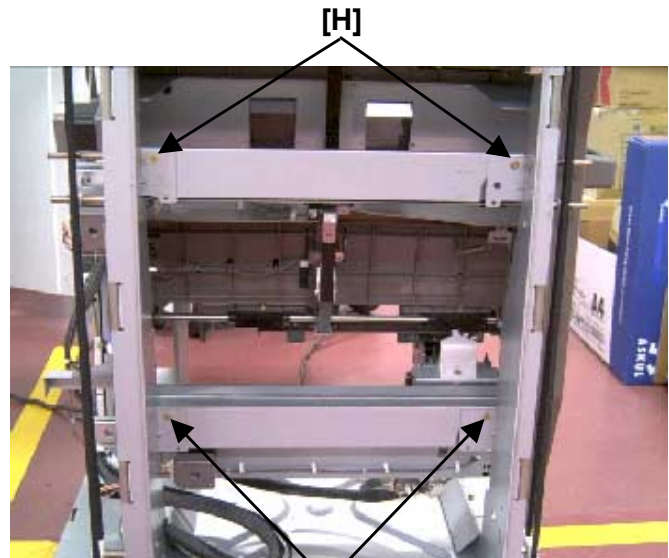
5. Remove the fixing screws [H] for the upper slide rail unit only.

**NOTE:** If the lower slide rail screws [I] are also removed here, the Stapler Unit will fall out.

[ I ]: Do not remove

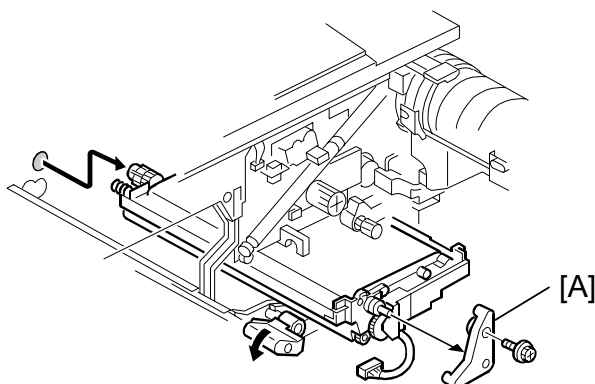
Due to a damaged special tool used on the production line, a 2.3mm gap developed between the positioning plate securing the transfer belt unit and the right edge of the machine frame (gap G<sub>1</sub> on next page, which should normally be about 1.5mm).

2. Remove the PCU Inner Cover (P/N B0651313), then remove the Transfer Unit Guide Plate [A].
3. Loosen the 2 paint-locked screws [B].
4. Insert a 1.5mm feeler gauge into the gap between the positioning plate [C] and the right edge of the machine frame (gap  $G_1$  in photo below), then tighten the two positioning plate screws.

6. If the belt has contacted the front edge, decrease gap  $G_1$  to 1.5mm or less. If it has contacted the rear edge, increase the gap starting at 1.5mm.

**NOTE:** Adjust the gap in increments of about 0.2mm. Then, repeat Steps 2 thru 6 until the transfer belt does not contact either edge through 100 sheets of duplex copies.

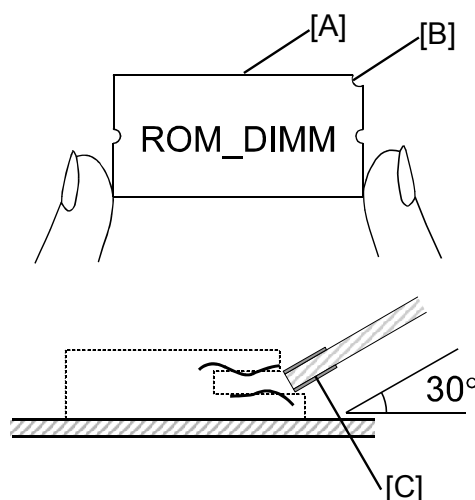
The following is the correct procedure for connecting ROM DIMMs to the controller board. Incorrect insertion can damage the controller board or cause a bad connection between the DIMM and controller contacts. If the upper contact is pressed in and bent, the resulting poor connection could cause the entire system not to operate.

1. Hold the ROM DIMM with the edge connector [A] pointing toward the slot and the notch [B] on the DIMM in the upper right-hand corner.
2. Insert the edge connector [C] into the slot at a 30-degree angle from the surface of the board.  
**NOTE:** If the angle is too low, the upper contact could bend.
3. Move the outside edge of the ROM DIMM up and down slightly until it works into the connector, then gently press it down level with the controller board.

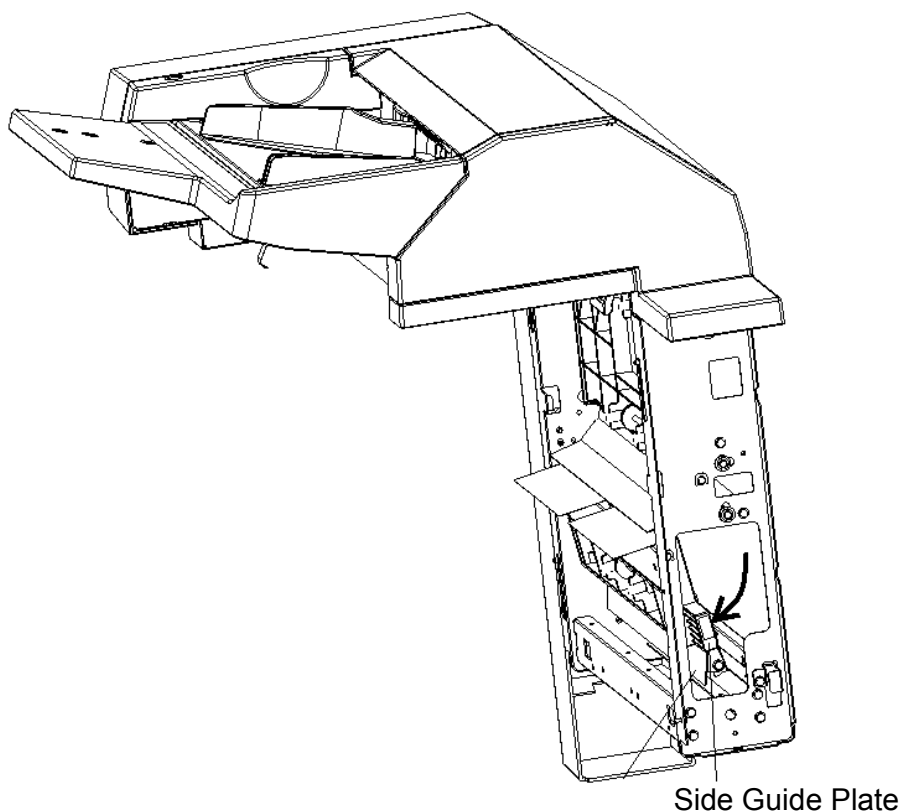
**Note:** When installing the finisher with the cover interposer tray, be sure to release (unlock) the entrance guide plate before docking the finisher with the machine. If the finisher is docked with the plate in the locked position, the plate may be damaged or fall off.

Please add the following note to **Step 19** of the installation procedure on page 1-38 of the Service Manual (illustration below for reference).

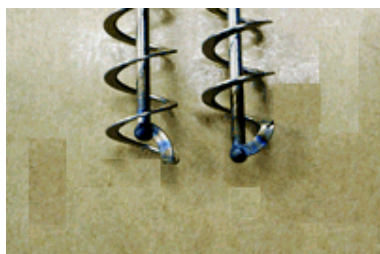
- Noise from the Toner Supply Unit (B0653110)
- Noise from the Toner Collection Assembly - Transfer (B0653551)
- Gears break (B0653138 and/or B0653139)
- Toner Collection Coil - Exit (B0653710) bends
- Toner leaks from the Development Filter (AA012060)
- Toner Collection Coil bends (AD043077)

The shape of the Transport Coil in the toner supply unit and the Transport Screw in the waste toner transport unit have been changed. Also, the steel ball in the lower waste toner transport unit has been deleted. In the photograph below, the old Transport Coil is shown on the right, and the new one on the left.

- Replace the Gear (B0653138 and/or B0653139), and
- Replace the Toner Supply Unit (B0653111) and Waste Toner Vertical Transport Unit (B0653554), and
- Remove the steel ball (A0963736).

**Note:** With gear replacement alone, the symptom will recur shortly thereafter. Also, individual replacement of the coil can allow waste toner to be blown out of the unit, so at the customer site, please be sure to replace the entire unit.

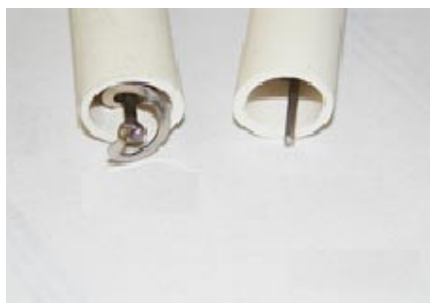
**Note:** The length of the coil in the Waste Toner Vertical Transport Unit has been increased as shown below (new coil on the left, old on the right). It is therefore necessary to remove the steel ball to prevent the loud noise that will occur if the coil contacts the ball.

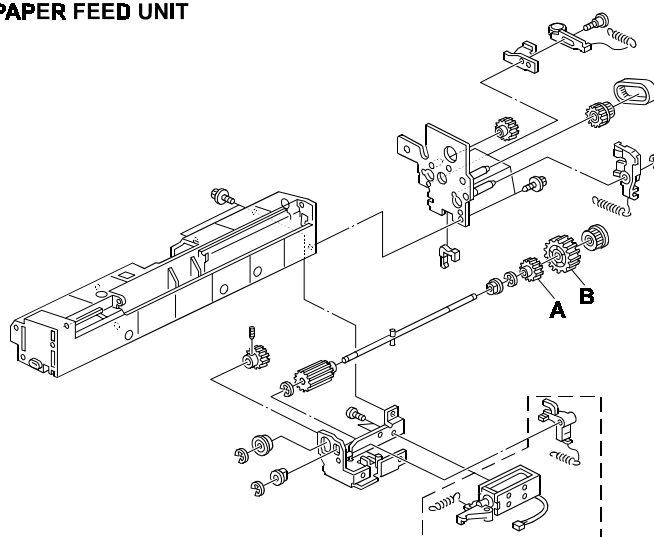
- (1) Using the following table, check the jam count values. For locations that show frequent occurrences, replace gears [A] and/or [B] below ***in which the arrow and cutout*** are as shown in the "NG" illustration.

As shown above, replace gears whose cutouts and arrows are in **different positions**.

- (2) Clean the shaft, then replace the gear(s).

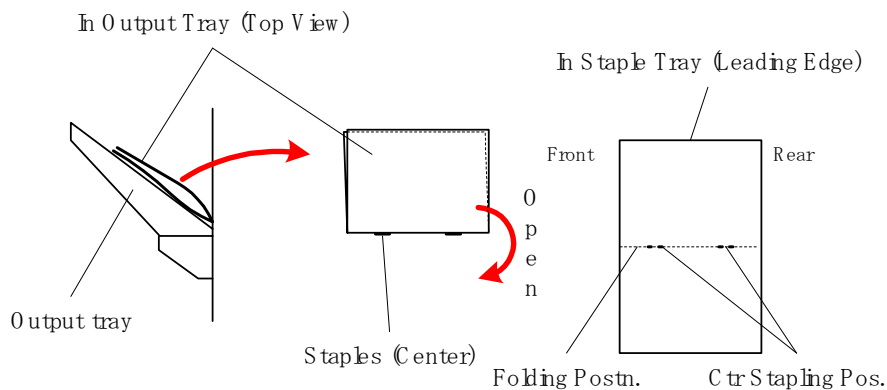
**Fig. 1: The Stack in the Output and Staple Trays**

The jogger fence gap is too wide, which prevents proper aligning of the stack's side edges.	<ul style="list-style-type: none"> <li>Check the current width of the jogger fence gap ("<b>Jogger Fence Gap Check</b>" below), and if necessary adjust the gap using <b>SP6120</b> (in the "-" direction).                          → See "<b>Adjusting the Jogger Fence Gap</b>" below.</li> </ul>

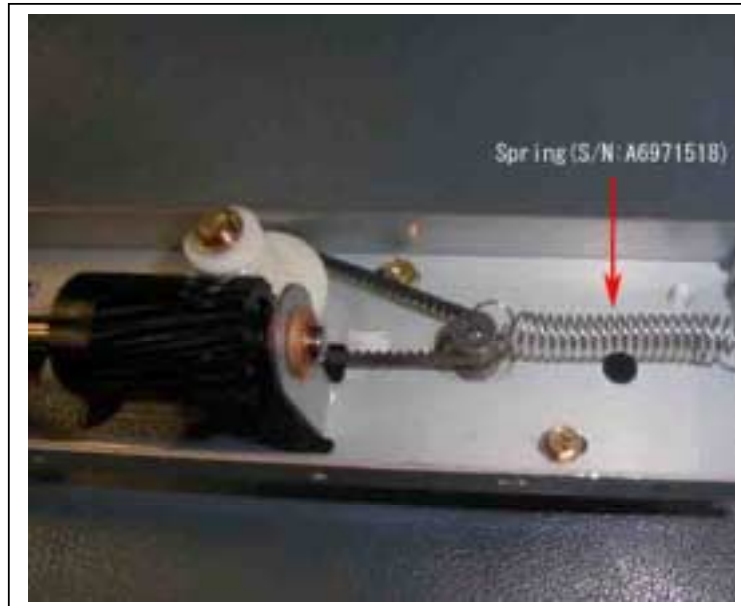
**Fig. 3**

Insufficient tension in the shift-transfer timing belt causes excess torque in the belt's motor

3. Attach the spring removed above to the area shown below (one end to the motor pulley, the other end to the edge of the stay). This spring will be used to apply the optimum tension in the belt ( $6 \pm 3.5\text{N}/3\text{mm}$ ).

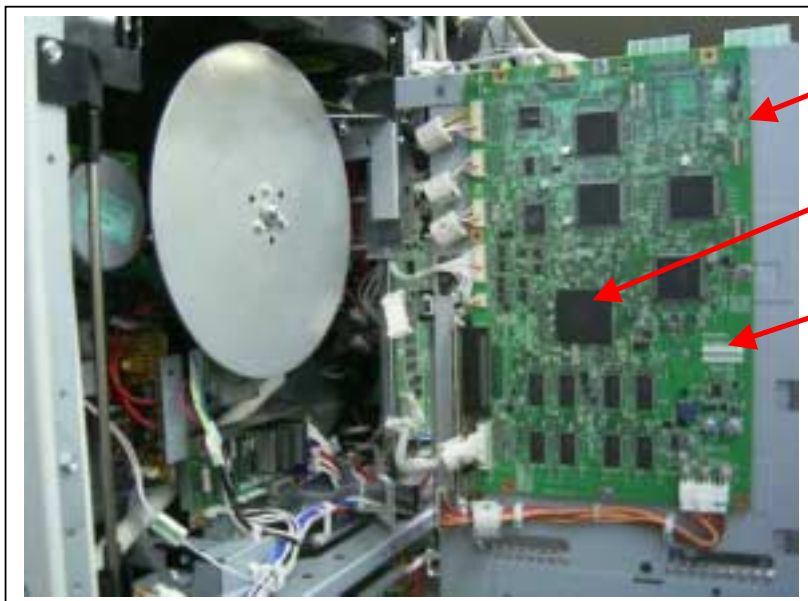
**Martini-C1 IPU Board (P/N:B1105140)**

Note: The symptom described above is limited to IC104, because its unique shape requires unique soldering conditions compared to other IC elements on the board.

IC104

Replace the IPU board with P/N B1105140.

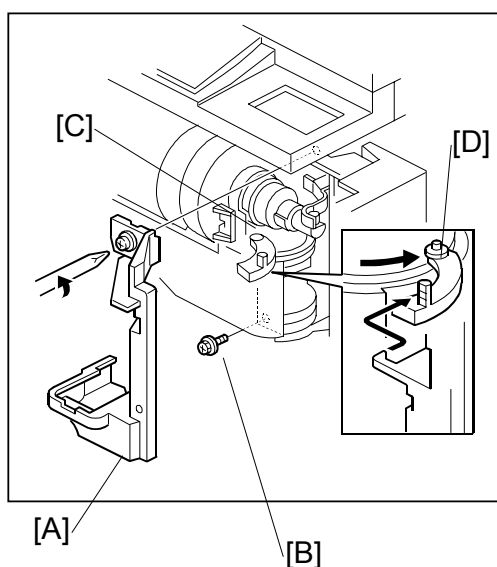
**Note:** If the toner bottle is in the machine when you do this procedure, the toner bottle holder can be damaged.

**IMPORTANT:** Before you begin, **remove the toner bottle** if it is installed.
