Model: Martini-C2	Date: 14-Oct-04	No.: RB140001b
-------------------	-----------------	----------------

Subject: Firmware Release History (BCU - Engine)		Prepared by: S. Watanabe	
From: 2nd Tech Support Sec. Service Support Dept.			
Classification:	<input type="checkbox"/> Troubleshooting	<input type="checkbox"/> Part information	<input type="checkbox"/> Action required
	<input type="checkbox"/> Mechanical	<input type="checkbox"/> Electrical	<input type="checkbox"/> Service manual revision
	<input type="checkbox"/> Paper path	<input type="checkbox"/> Transmit/receive	<input type="checkbox"/> Retrofit information
	<input checked="" type="checkbox"/> Other ()

This RTB has been issued to announce the firmware release information for the Engine.

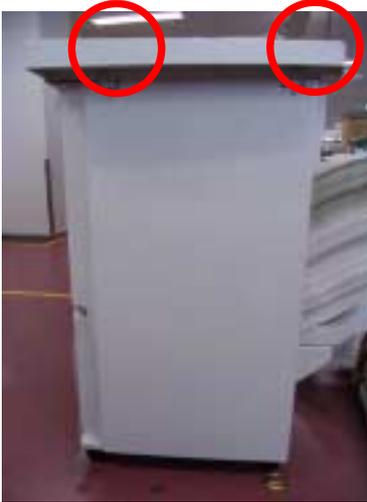
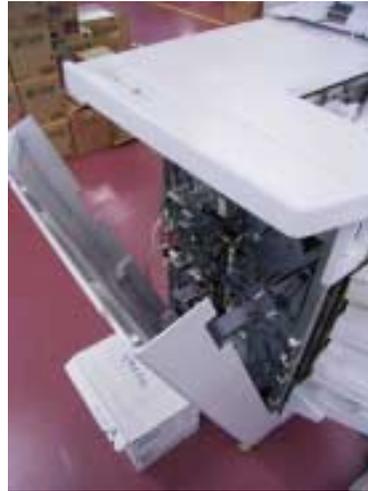
1. Remove the two screws shown in the left photo.
2. Remove the I/F cable from the mainframe.
3. Remove the front cover and remove the I/F cable from the cutout in the front cover.

Install EP-ROM #B7065107 on the main control PCB (replacement procedure below).

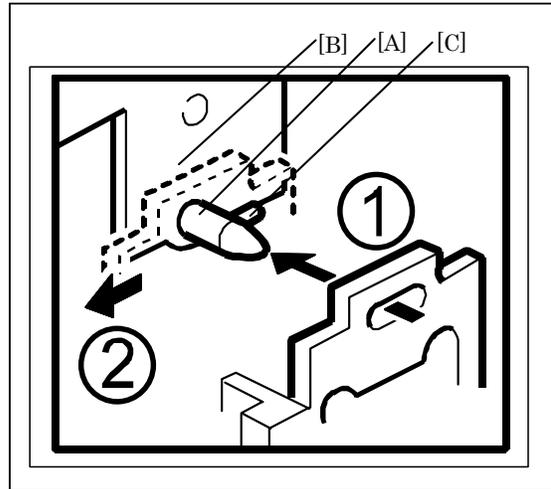
- **Note:** Steps 5-13 of the procedure on pg. 1-11 were not changed.
- **IMPORTANT:** As mentioned below, before you begin the procedure on pg. 1-11, make sure to **remove the toner bottle first**. If the toner bottle is in the machine when you do this procedure, **the toner bottle holder can be damaged**.

1. Remove the shutter cover [A] of the toner supply unit (⌀ x 1).
2. Remove the lock screw [B] from the toner bottle open/close bracket.
3. Remove the shipping tape [C] if it is still there.
4. Pull the toner bottle holder and swing it to the right.

14. Push the development unit all the way to the right.
15. Continue to hold the unit to the right and push it into the machine.
Important: Make sure the pin [A] goes into the left side of the hole in the development unit plate.
16. Push the development unit all the way in, so that the development unit plate touches the mainframe plate [B].
Important: Make sure you can see the small pin [C] in front of the plate. If you cannot move the development unit plate behind the small pin, turn the front gear of the unit to the left, and try again.
17. Push the development unit to the left until it touches the PCU.
18. Rotate the pipeline shutter down to the open position.
19. Reattach all the parts you removed in Steps 1-4 of this procedure.
Important: Make sure the tab [D] is behind the stay and the lower pin is inside the track.
